**R10 - TSCA/PCB EPA INSPECTION**  
**CONCLUSION DATA SHEET (ICDS)** (Rev April 2008)

1. Facility Name: Rainier Commons, LLC

**EPA Region 10  
PCB Compliance Inspection Report**

**Inspection Date:** March 24, 2009

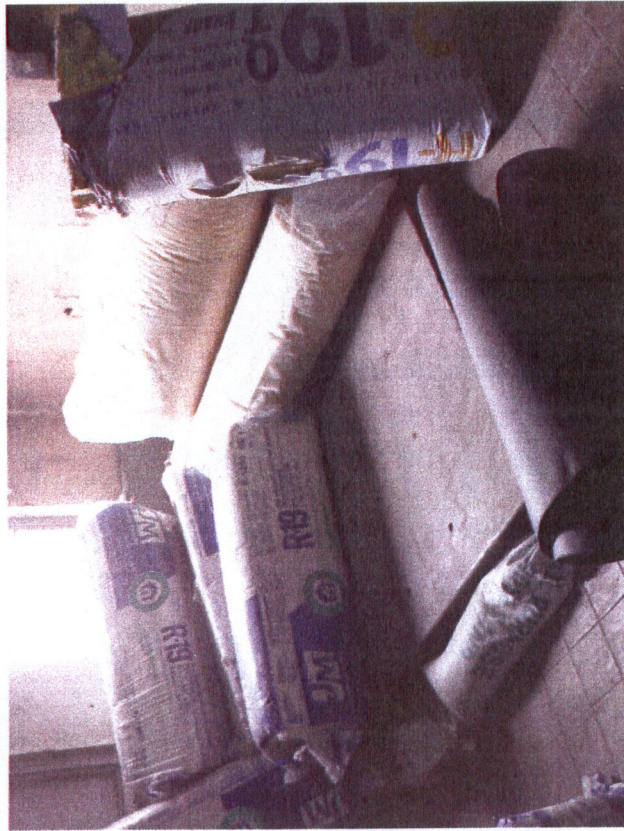
**Photo No:** P1000860

In Building 5 on the fourth floor (Noted as Floor 400) was a raised concrete pad, which is believed to be a former location for a transformer (Photograph No. P1000860). The materials stored on the pad were removed and I saw no sign of oil stains or any decolonization to the concrete. Mr. Alon said to me, the transformer had to have been removed long before Rainier Commons purchased the property.

**Description:** Former location of a pad mount transformer inside Building 5 on Floor 400. The Farallon Report dated April 2004 stated there were leaking transformers at the Brewery, but did not identify the location of the leaking transformers. There was no visible evidence there had been any leaking transformer oil on this concrete surface.

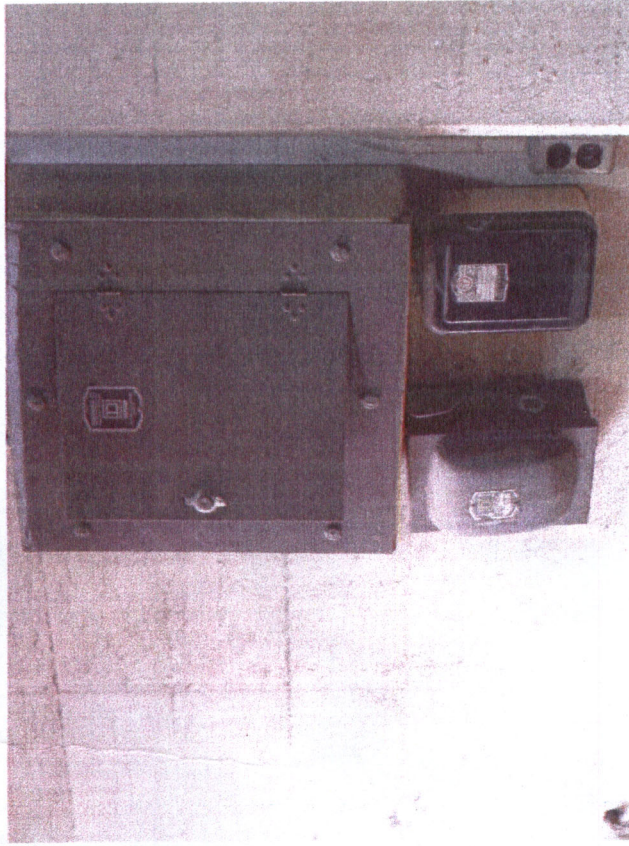
There were some electrical switches and a fuse box on the wall in Building 5 (Photograph No. P1000862 and P1000864). These articles were not oil filled and there was no leaking potting compound from these articles.

**Description:** Electrical switches on the wall near the former transformer pad inside Building 5 on Floor 400. All were dry and no visual evidence of leaking oil, present or in the past.

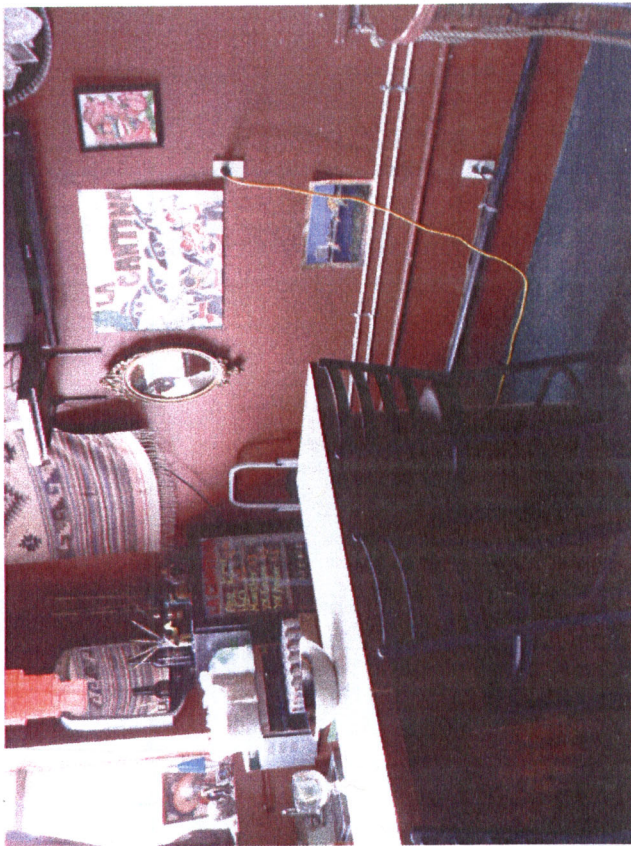
**Description:** The northwest corner of Building 25 is a food and drink establishment. The north end of the bar is a former location of a transformer. The floor of the bar has been recovered and the walls painted. There is no sign of past oil leaks from equipment that may have been previously located in the room.

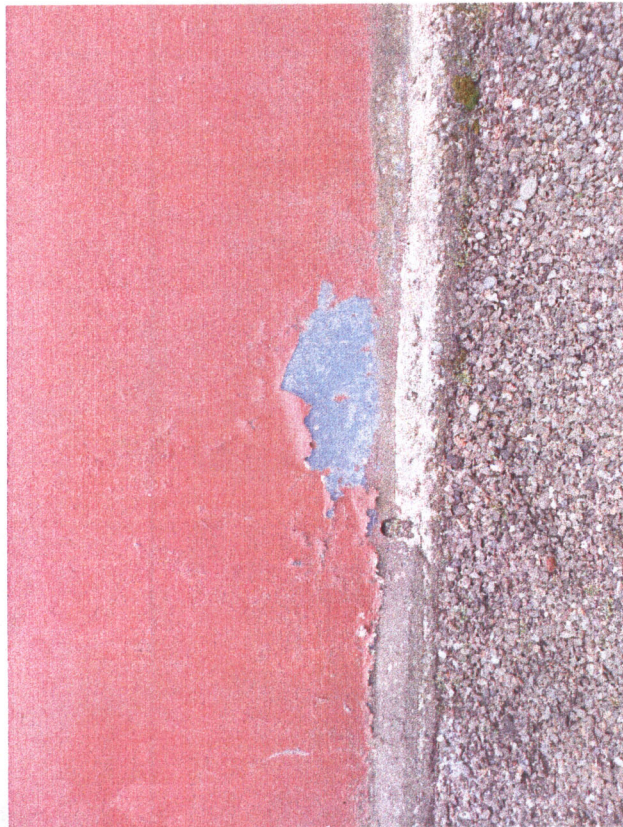
**Photo No:** P1000870

**Description:** In the Vernon Environmental Report date June 2006 it was identified to Rainier Commons that the old brewery buildings contained PCBs at concentration greater than 2000 mg/kg. EPA collected a sample of the paint from the west wall of Building 13 (Sample No. 09124301). The results of the analysis shows PCBs in the paint greater than 2000 mg/kg.

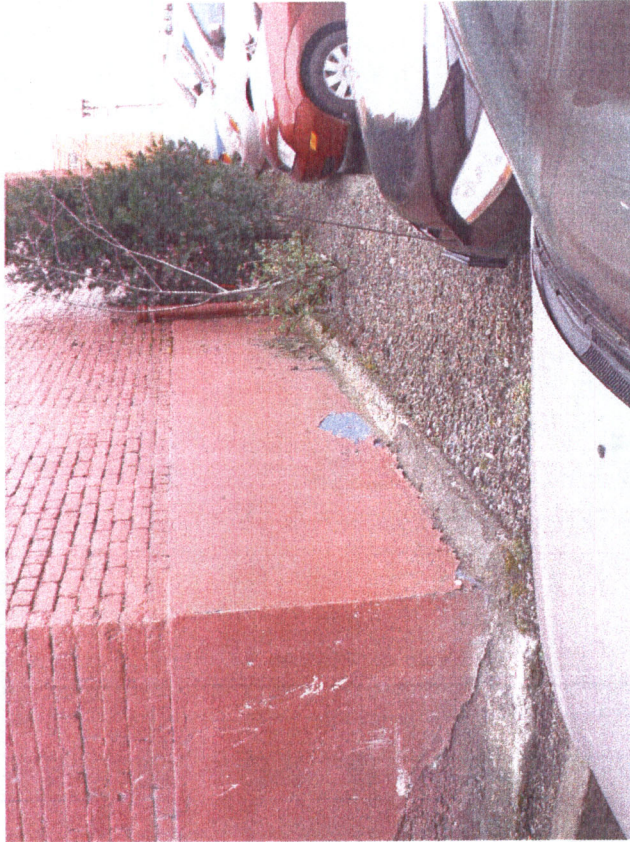
**Description:** The gravel strip in front of the west wall of Building 13 is covered with paint chips that have broken off the buildings surface. Rainier Commons' consultant suspected that during a rain event these paint chips migrate into the catch basins around the building. The west wall of Building 13 is up-hill to Catch Basin 3 and 2 (See Draft Catch Basin Plan).

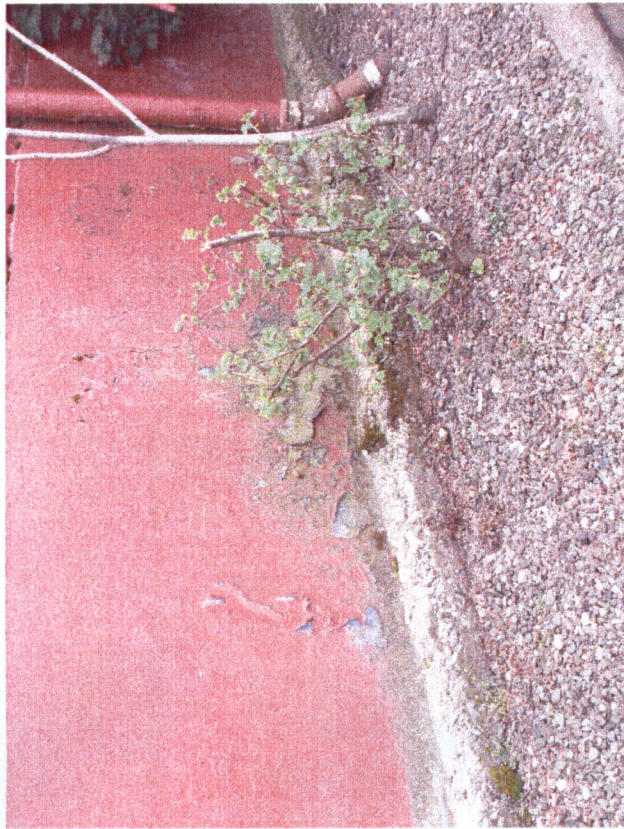
**Photo No:** P1000871

**Description:** The colorful reflection in the gravel strip is paint chips. EPA collected paint chips along the west wall of Building 13. EPA collected paint samples from the paint chips in the gravel strip and in the parking lot leading to the Catch Basins (Sample No. 09124302). The analysis shows PCBs greater than 2000 mg/kg.

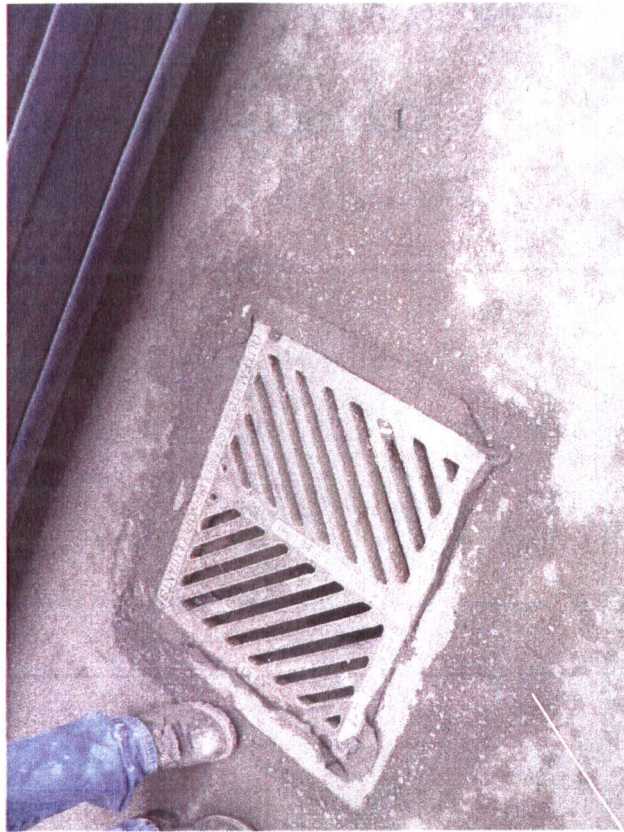
**Description:** This is a typical catch basin cover. In January 2009, Rainier Commons added silt socks to the catch basin. This sock is designed to collect sediment and paint chips that are picked up by the rain. There is a locking device on the metal cover. EPA was not able to unlock the cover for sample collection at this time of this inspection.

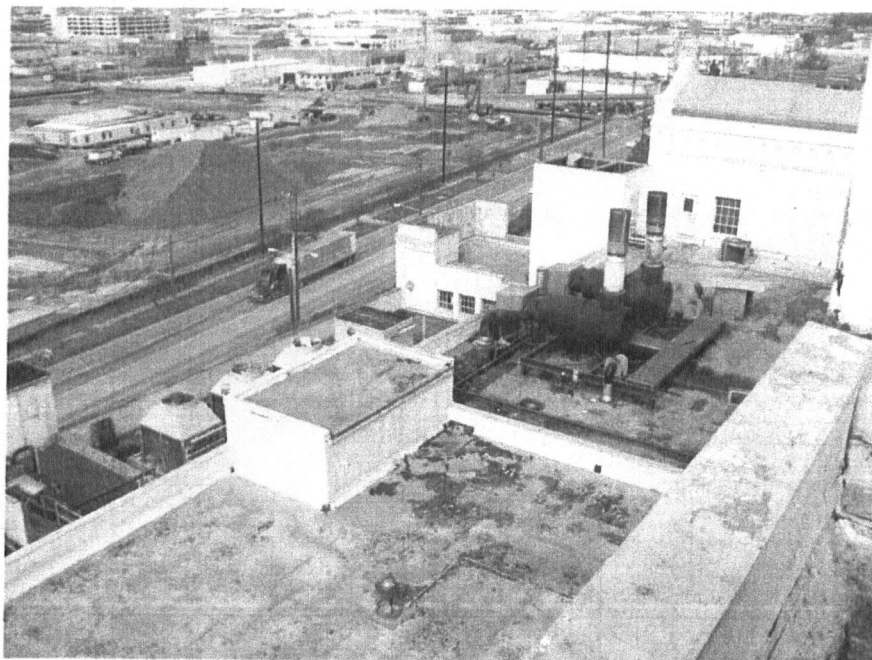
**Photograph 5:** Facing northwest; view of afterburners on roof of Building 6.

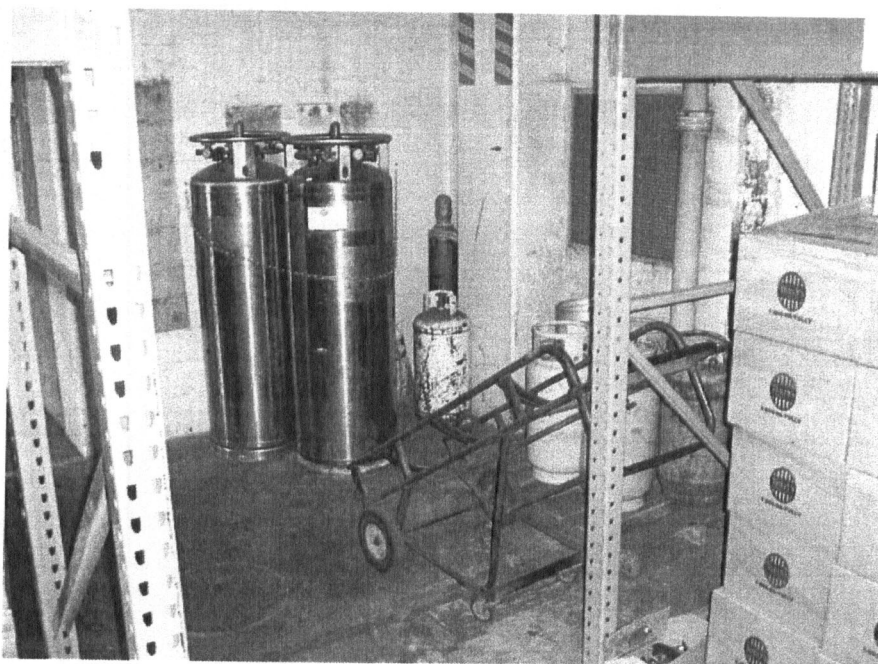
**Photograph 8:** Facing northeast; view of three nitrogen and five propane tanks on 2<sup>nd</sup> floor of Building 9.

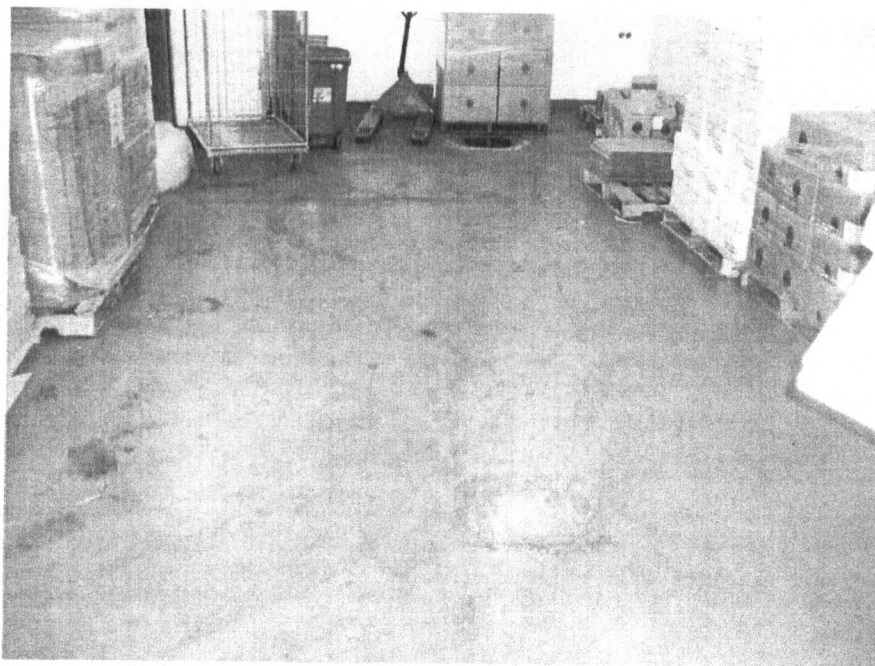
**Photograph 10:** Facing north; view of sealed floor drains on 1<sup>st</sup> floor of Building 14.

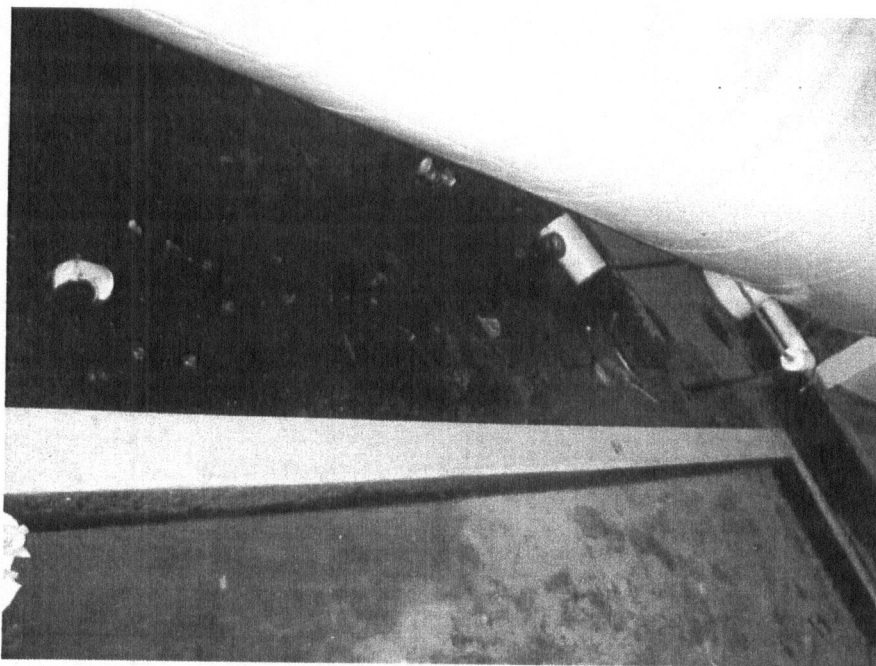
**Photograph 12:** Facing northeast; view of pooled oil beneath aboveground storage tank on 2<sup>nd</sup> floor of Building 14.

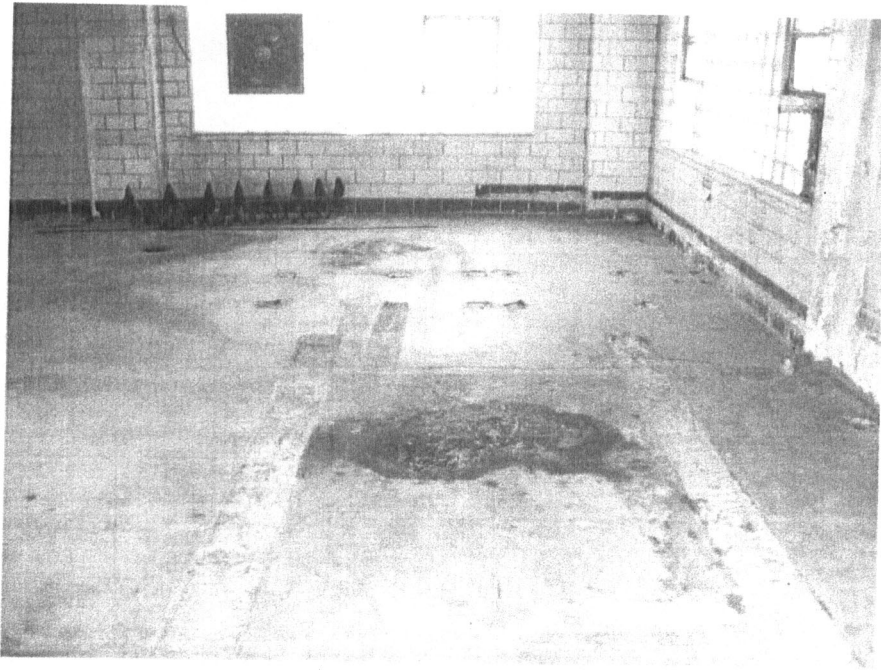
**Photograph 17:** Facing west; view of staining around drain on 6<sup>th</sup> floor of Building 21.

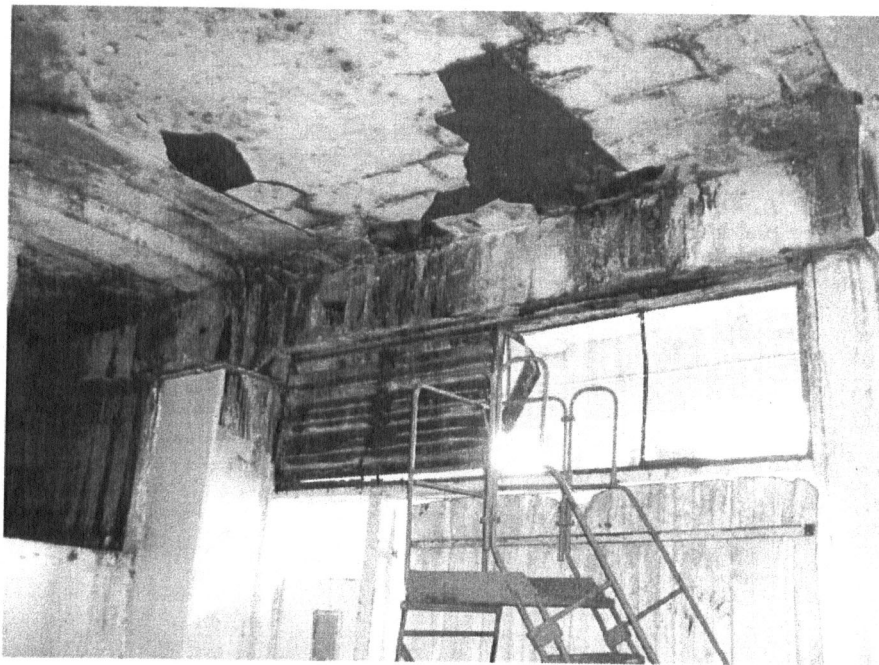
**Photograph 18:** Facing southeast; view of staining on wall, ceiling, and vent plenums on 2<sup>nd</sup> floor of Building 25, near rear exit.

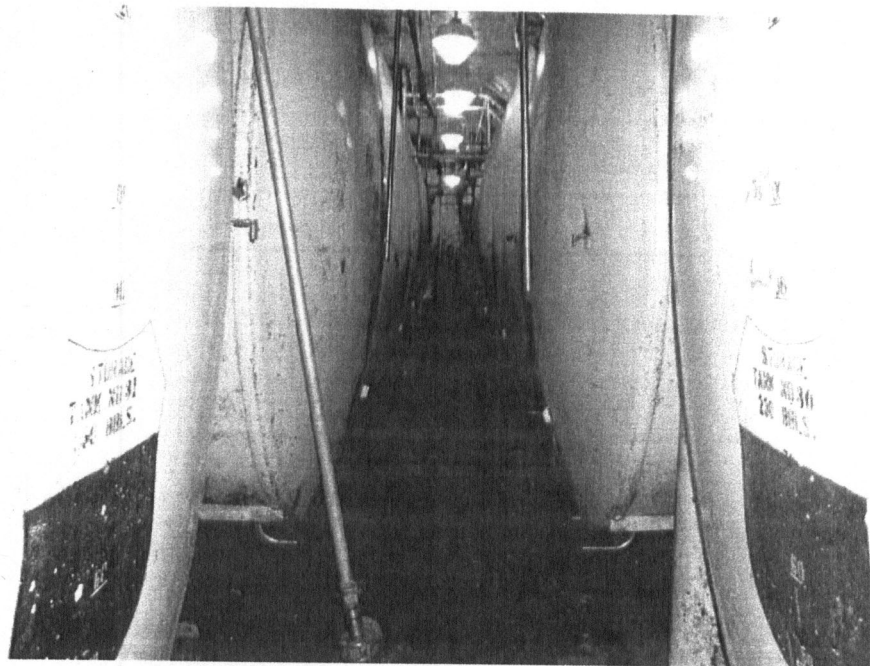
**Photograph 19.** Facing south; view of fermentation aboveground storage tanks on 3<sup>rd</sup> floor of Building 25.

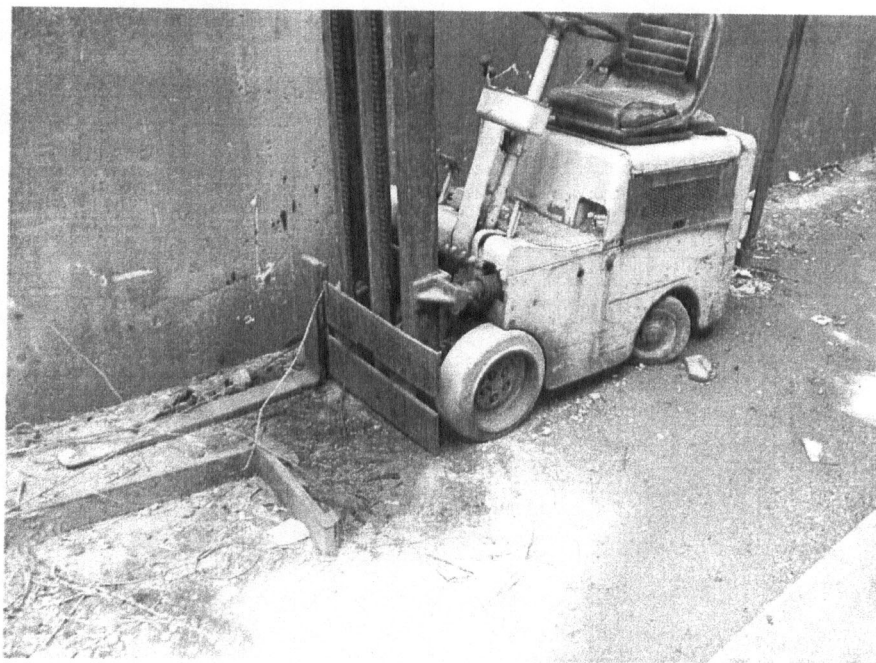
**Photograph 20.** Facing southeast; view of abandoned forklift in driveway beneath Building 21.
